# Engineering geological and geotechnical evaluation of Sathya Sai Prasanthi Nilayam railway tunnel, Andhra Pradesh, India

A. K. Naithani\*, Prasanna Jain

Engineering Geology Department, National Institute of Rock Mechanics, Bengaluru 560070, India

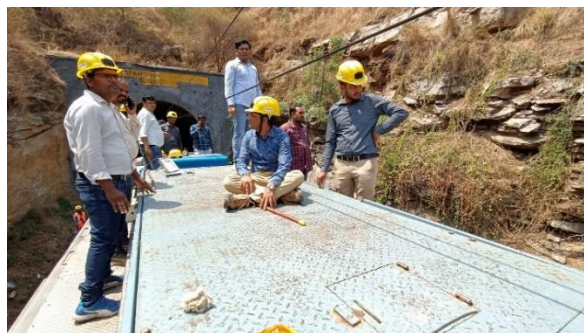
**Figure 2.** Crown data was collected using the tower car.

3D engineering geological mapping was carried out in 1:100 scale, so that minor geological features can also be mapped. Tunnel crown data was collected using the tower car as shown in **Figure 2**, and for better interpretation, data was also collected from the ground, along the tunnel alignment (**Figure 3**). Brunton Compass, Schmidt Hammer and Total Station Surveying instruments were used for data collection. 3D engineering geological mapping provides a permanent record of all geologic features exposed on the crown and walls of an underground excavation which is very useful in understanding the future failure in case the tunnel is lined. All engineering geological parameters were collected and measured from the rock mass for the characterization of rock mass (**Figure 4**). ISRM [4] classification for weathered rock mass was used to characterize the rock mass into different weathering grades.

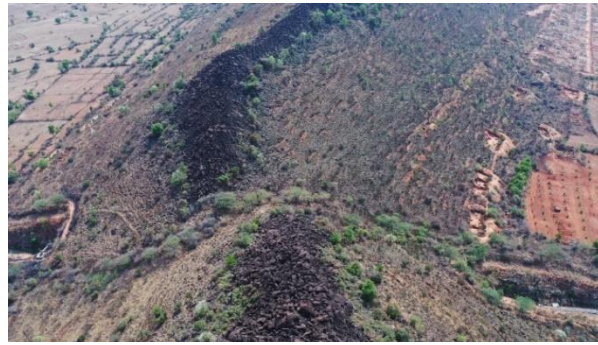
Figure 3. Bird-eye view of the tunnel.

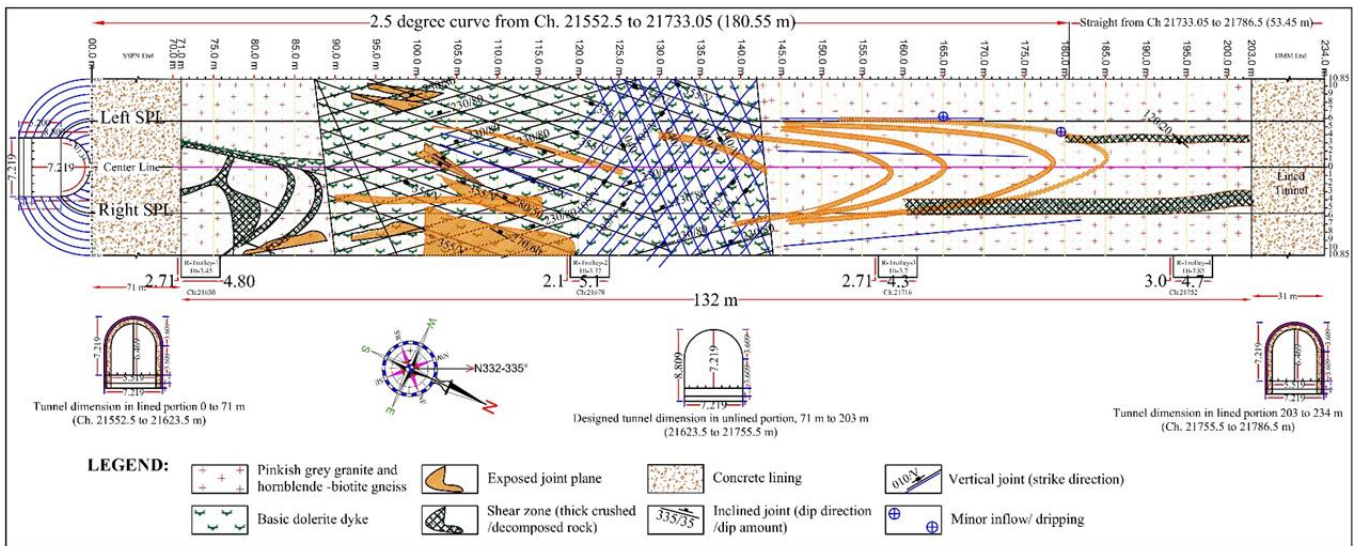
Figure 4. 3D geological map of the tunnel.

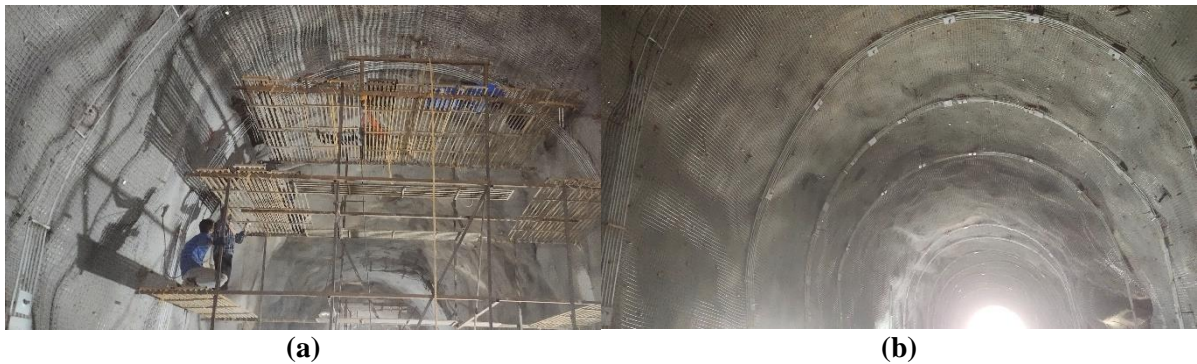
**Figure 6.** (a) installation of reinforced ribs of sprayed concrete; (b) view of tunnel after installation of RRS.

Based on  $Q$ -values, site geological conditions and engineering judgement, support for the tunnel was recommended which includes rock bolt, fibre reinforced shotcrete (SFRS/PFRS), grouting and reinforced ribs of sprayed concrete (RRS) (Table 5). Proper scaling and cleaning (with water jet and air jet) of the excavated rock faces before execution of support was recommended. A combination of sub-horizontal and sub-vertical joints may create a problem at the crown which may not be seen before failure, and for the same longer rock bolts were recommended. Rock bolts will be equipped with an anchor plate with spherical hexagonal washer and nut. It was suggested that the protruding end of the bolt shall have a minimum of 150 mm threads and the projections of the rock bolt should be fully covered with shotcrete to prevent corrosion. Cement grouting in rock bolting holes before fixing of bolts was suggested. The undulations on the rock face should be chiseled properly before rock bolting to get uniform face slope. There should be a proper contact between the bearing plate and the rock surface. The size of the bearing plate recommended was  $200 \times 200 \times 10$  mm. RRS thickness will be 300–400 mm, centre to centre spacing will be 4.0 m, number of 20 mm dia steel bars of in one rib will be 6 which will be equally spaced and welded by 25 mm dia bar or  $200$  mm ( $W$ )  $\times$   $300$  mm ( $L$ )  $\times$   $15$  mm ( $T$ ) steel plate. Welding will be done at 2.0 m interval and anchoring at 2.0 m interval and 1.0 m deep in a rock mass. First two layers of SFRS will smooth out the rock surface, which is very essential for placing RRS. All the recommendations made were implemented by agency and now this track is reopened for the trains (Figure 6a,b).

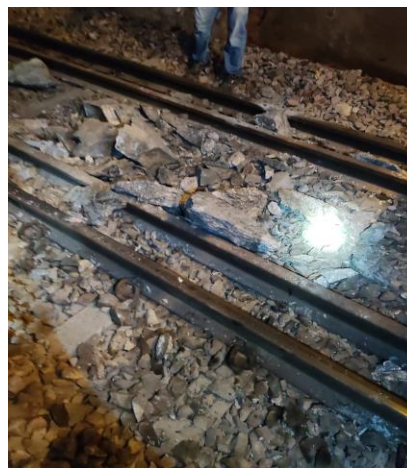
This is a critical example where engineering geological investigations were started after the rock block started falling from the crown on the railway track (**Figure 7**). This may be hazardous and some time may be a huge economic loss to the Corporation who is looking after the maintenance part of the railway track if the track is closed for long time.

**Figure 7.** Falling of rock block from the crown of tunnel.
